Manhole Inspection Summary

Manhole # S17Y__017MH

Inspection ☐ Is Incomplete Rating: **3) Fair**

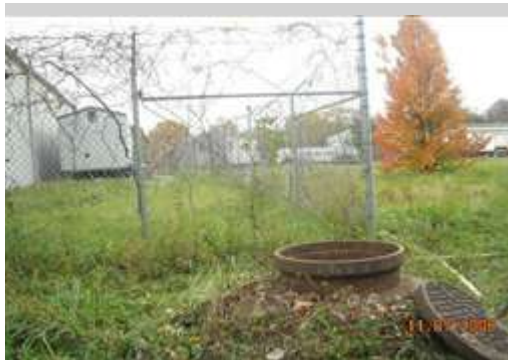
Location View

Comments **LOCATED JUST OUTSIDE THE PROPERTY FENCE FOR ANDERSON INDUSTRIAL CONTRACTORS. FRAME IS NOT ATTACHED TO STRUCTURE.**
